# Historic Furnishings Report Painted Desert Inn

Petrified Forest National Park  
Petrified Forest, Arizona

## **PAINTED DESERT INN PETRIFIED FOREST NATIONAL PARK**

**Northeast Museum Services Center  
National Park Service  
May 2004**

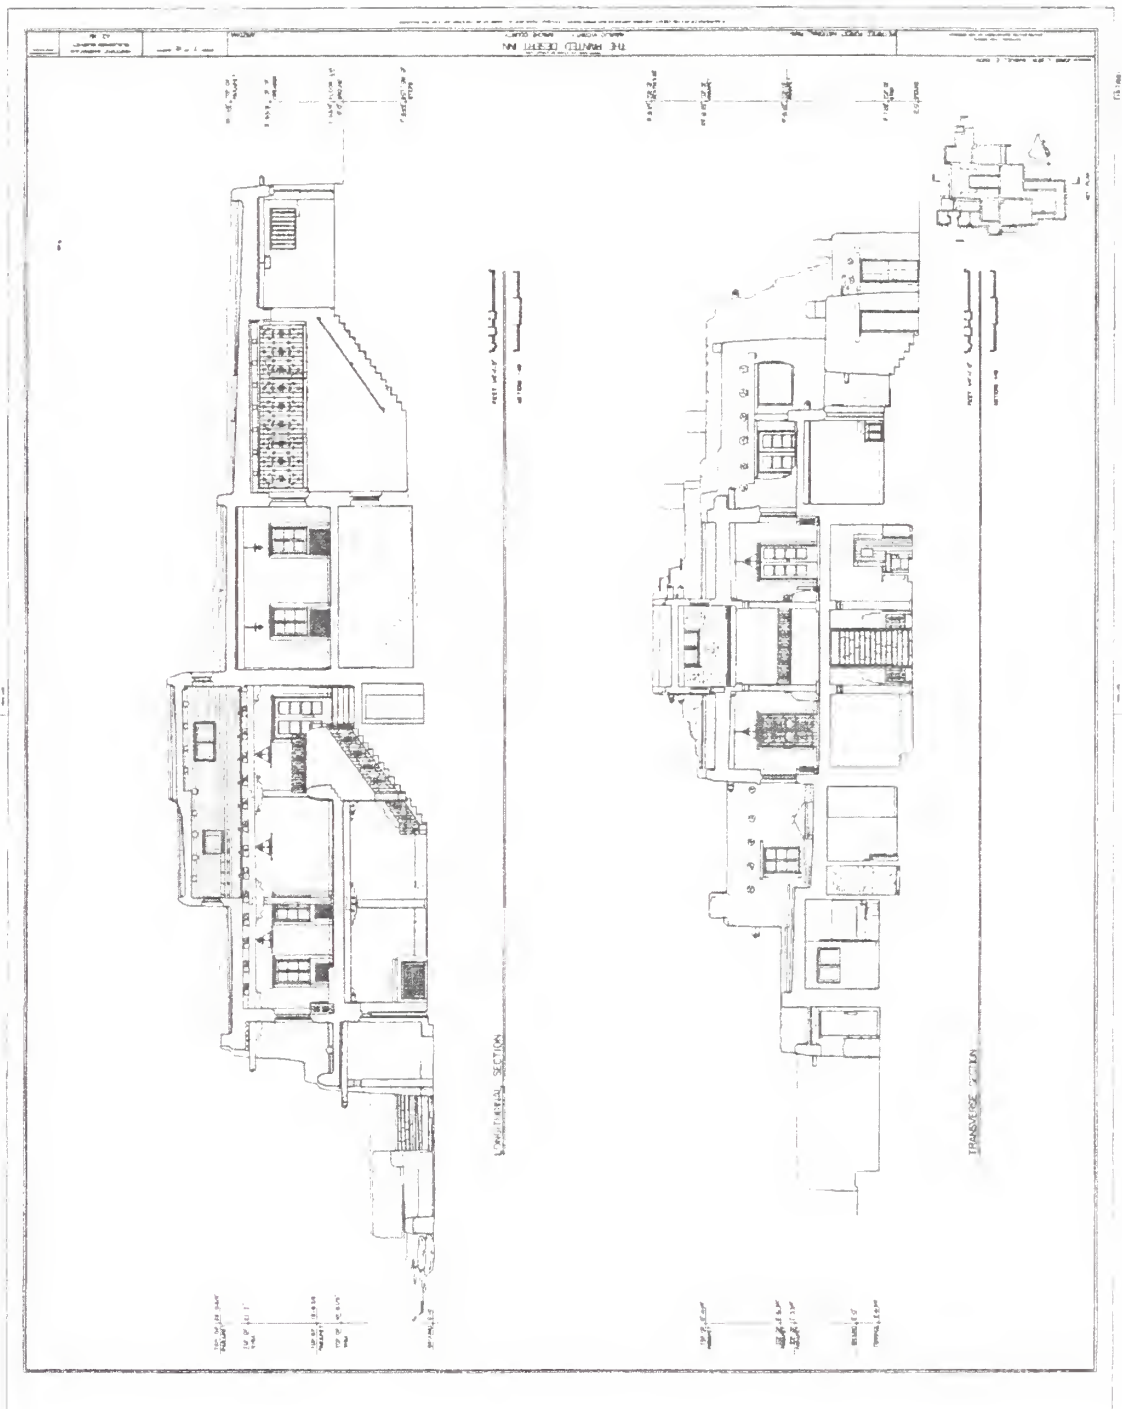
3. "Transverse Section of Painted Desert Inn." 1992, Drawing by Historic American Buildings Survey, Museum Collection, Archives, Petrified Forest National Park, Petrified Forest, Arizona, HABS: AZ-161, sheet 7 of 12.

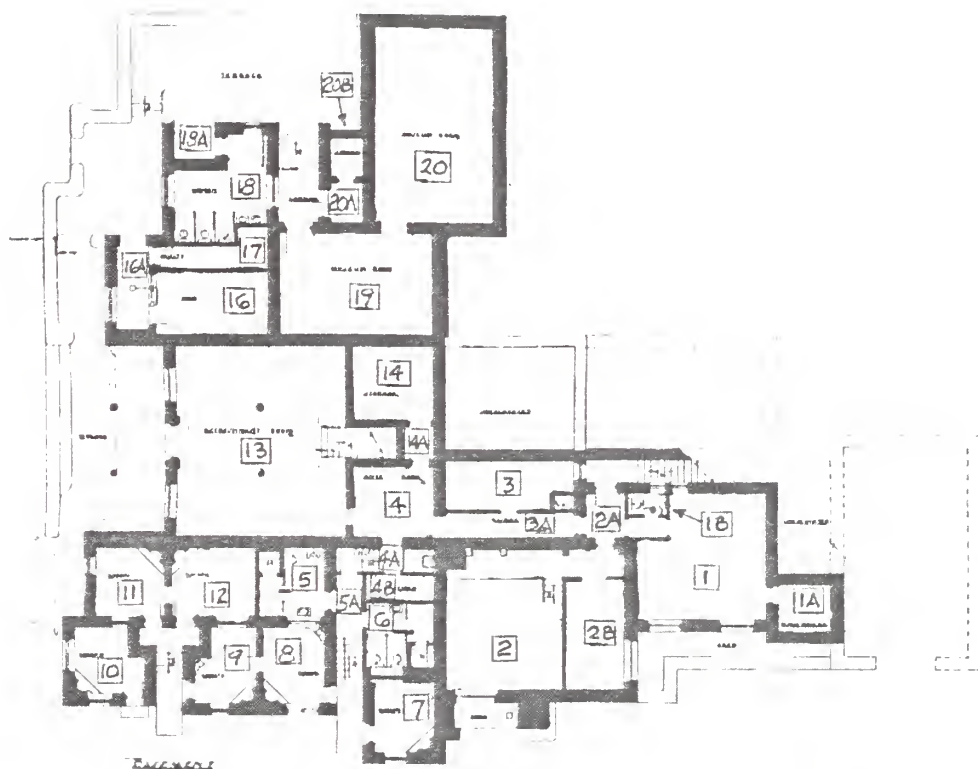
4. "Painted Desert Inn Basement Plan with Room Numbers." 1992, in *Historic Structure Report: Painted Desert Inn, Petrified Forest National Park* (Denver: Denver Service Center, United States Department of the Interior, October 1994), 56.

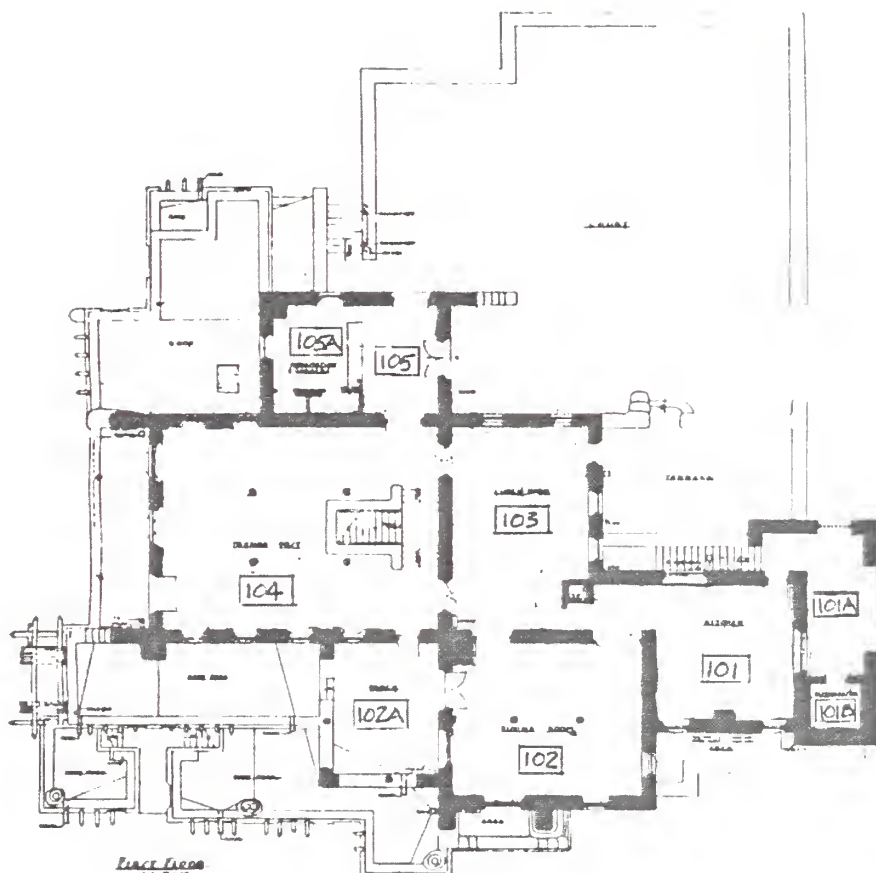
5. "Painted Desert Inn First Floor Plan with Room Numbers." 1992, in *Historic Structure Report: Painted Desert Inn, Petrified Forest National Park* (Denver: Denver Service Center, United States Department of the Interior, October 1994), 57.

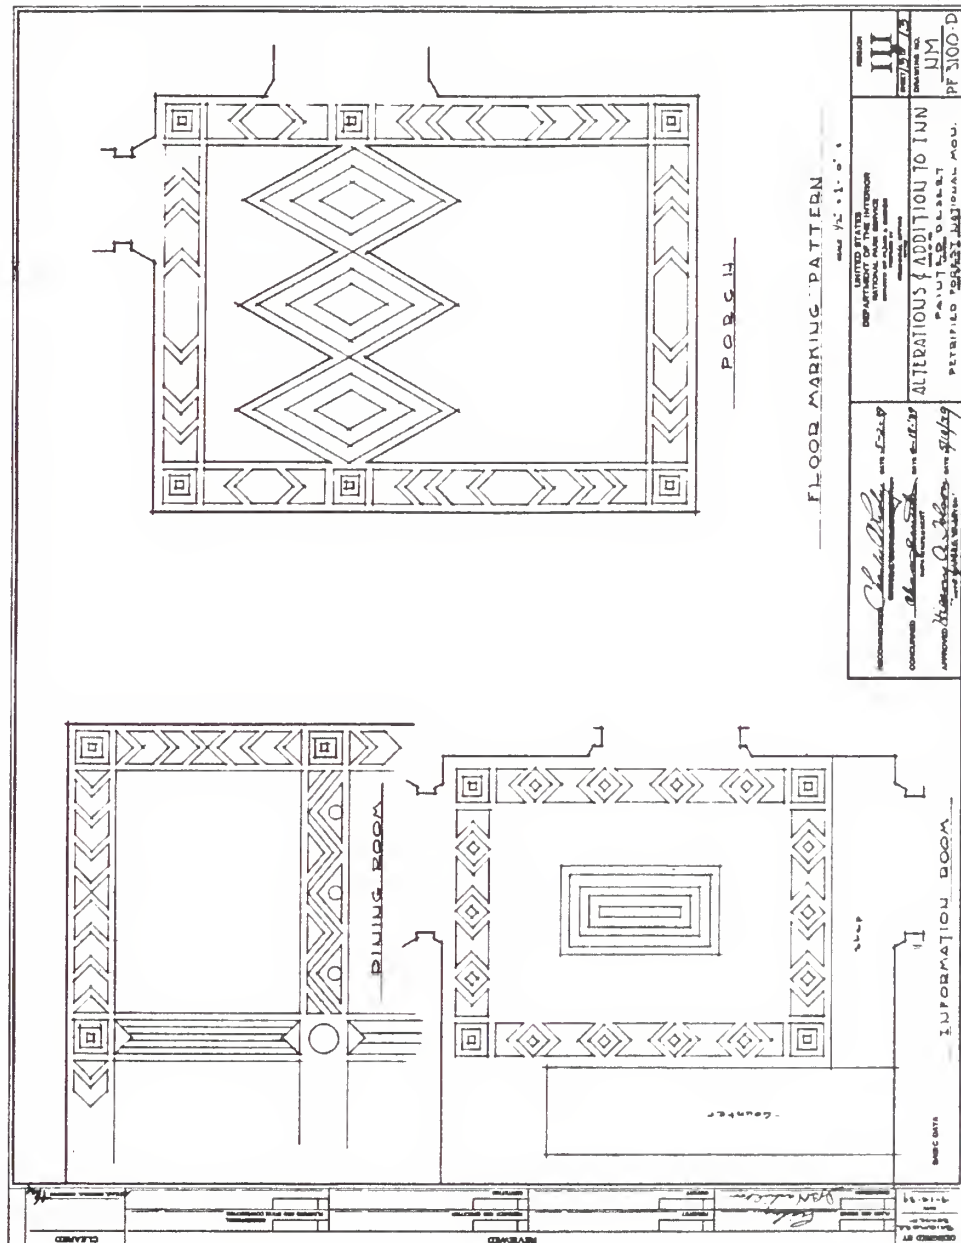
6. "Scoring Patterns for Concrete Slabs in Room 102, 102A and 105."  
April 1939, Plan by Lyle Bennett, Museum Collection, Archives,  
Petrified Forest National Park, Petrified Forest, Arizona, PF 3100-D,  
Sheet 13B.

The HSR also recommends that the concrete floors scored in a decorative pattern (present in the dining room, porch 101a, and porch 102a) be restored to their historic 1939-1949 stained finish. Strictly speaking, this recommendation falls within the park's target period of significance, 1947-1950. However, Mary Colter's 1949 decorative scheme for the Fred Harvey Company designated these floors be painted over with gray paint. Also, the finishes analysis did not analyze any floor samples, so it is unknown how the scored concrete appeared through time.

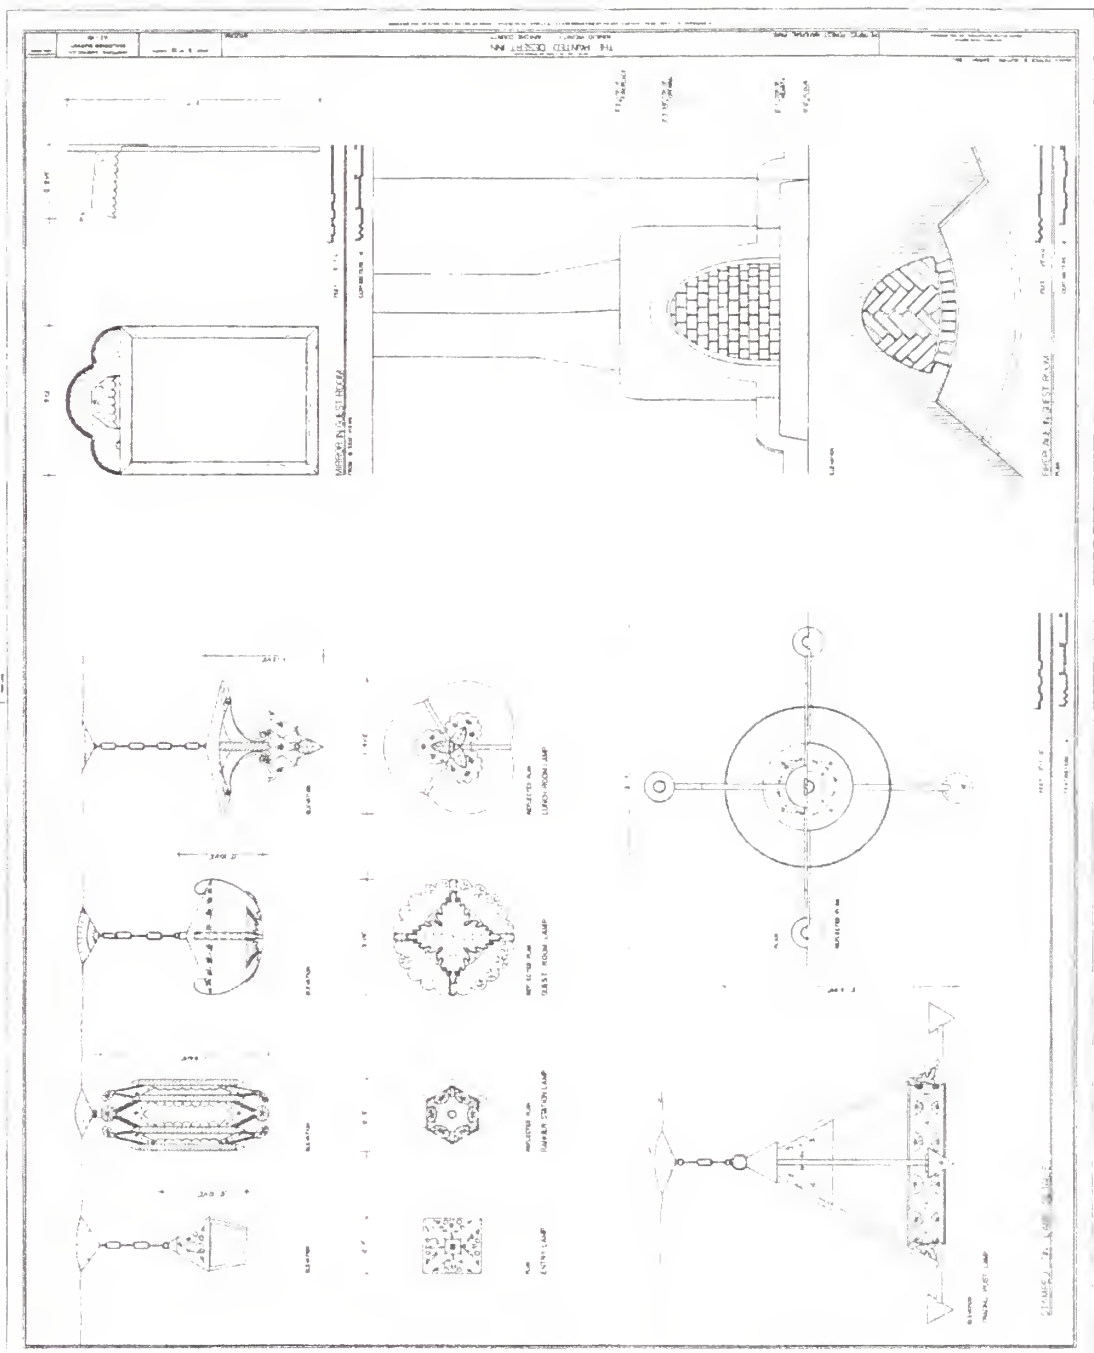
8. "Stamped Tin Lamp Details." 1992, Drawing by Historic American Buildings Survey, Museum Collection, Archives, Petrified Forest National Park, Petrified Forest, Arizona, HABS: AZ-161, sheet 9 of 12.

One tin lighting fixture in the lunchroom has been conserved. Others that currently hang in the Painted Desert Inn dining room, lunchroom, trading post room, ranger room, and guest room are intact but need to be assessed in terms of condition. Other tin fixtures in storage all need to be conserved and vary in terms of condition. Once conserved, *in situ* extant shelving and furnishings (such as the tap room bar, and fogon fireplaces in the guest rooms) can be used as installation objects.

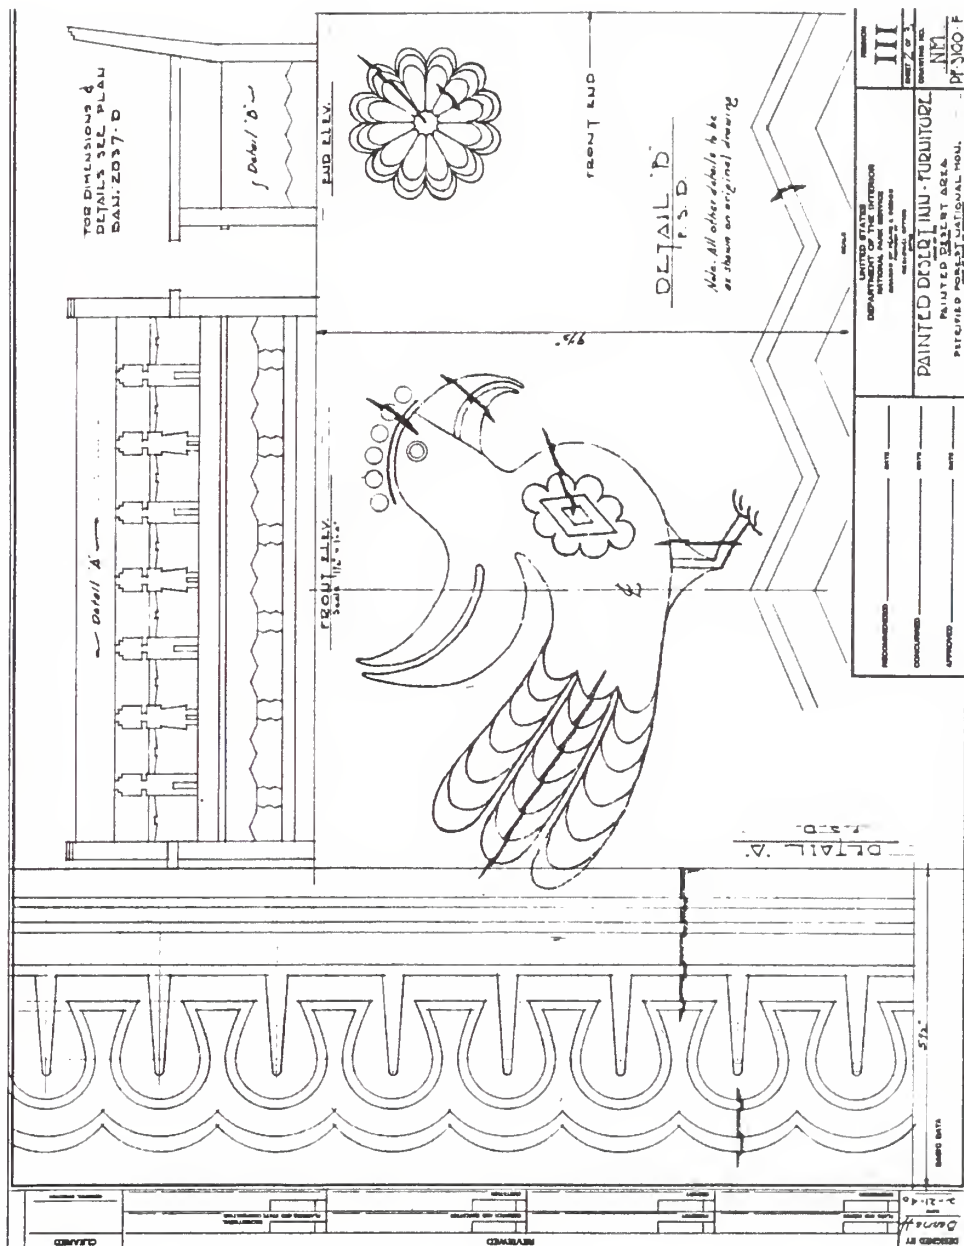
29. "Furniture--Details of Wood Bench in Lunchroom with Carved Decorative Patterns." February 1940, Plan by Lyle Bennett, Museum Collection, Archives, Petrified Forest National Park, Petrified Forest, Arizona, PF 3100-F, Sheet 2.

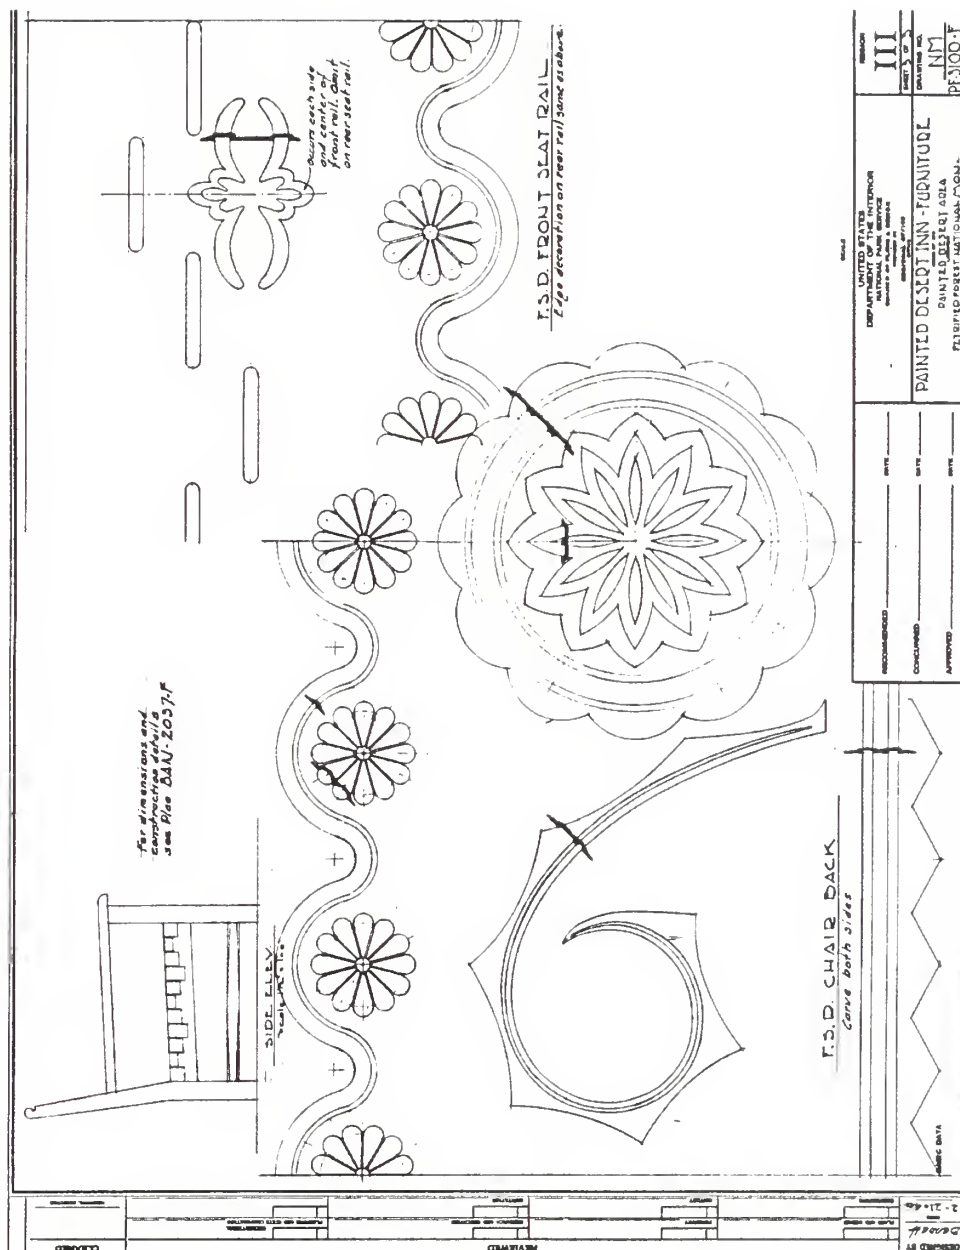
30. "Furniture--Details of Wood Bench with Carved Decorative Patterns."  
February 1940. Plan by Lyle Bennett, Museum Collection, Archives,  
Petrified Forest National Park, Petrified Forest, Arizona, PF 3100-F,  
Sheet 3.

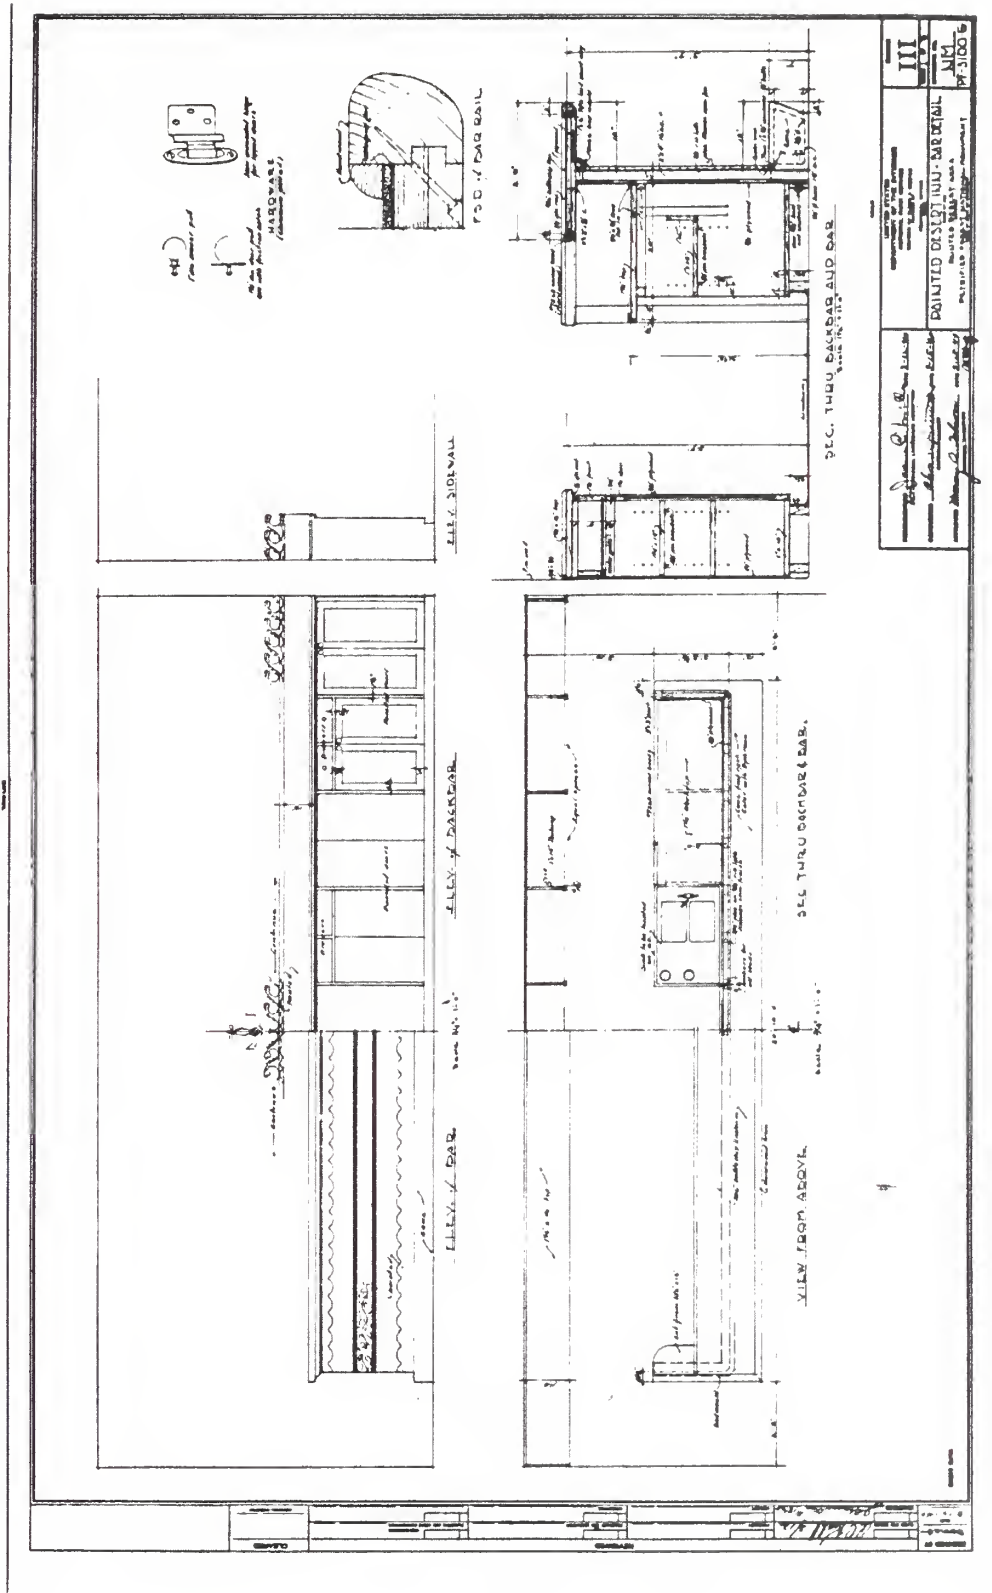
31. "Bar Detail." March 12, 1940, Plan by Lyle Bennett, Museum Collection, Archives, Petrified Forest National Park, Petrified Forest, Arizona, PF 3100-G, Sheet 1.

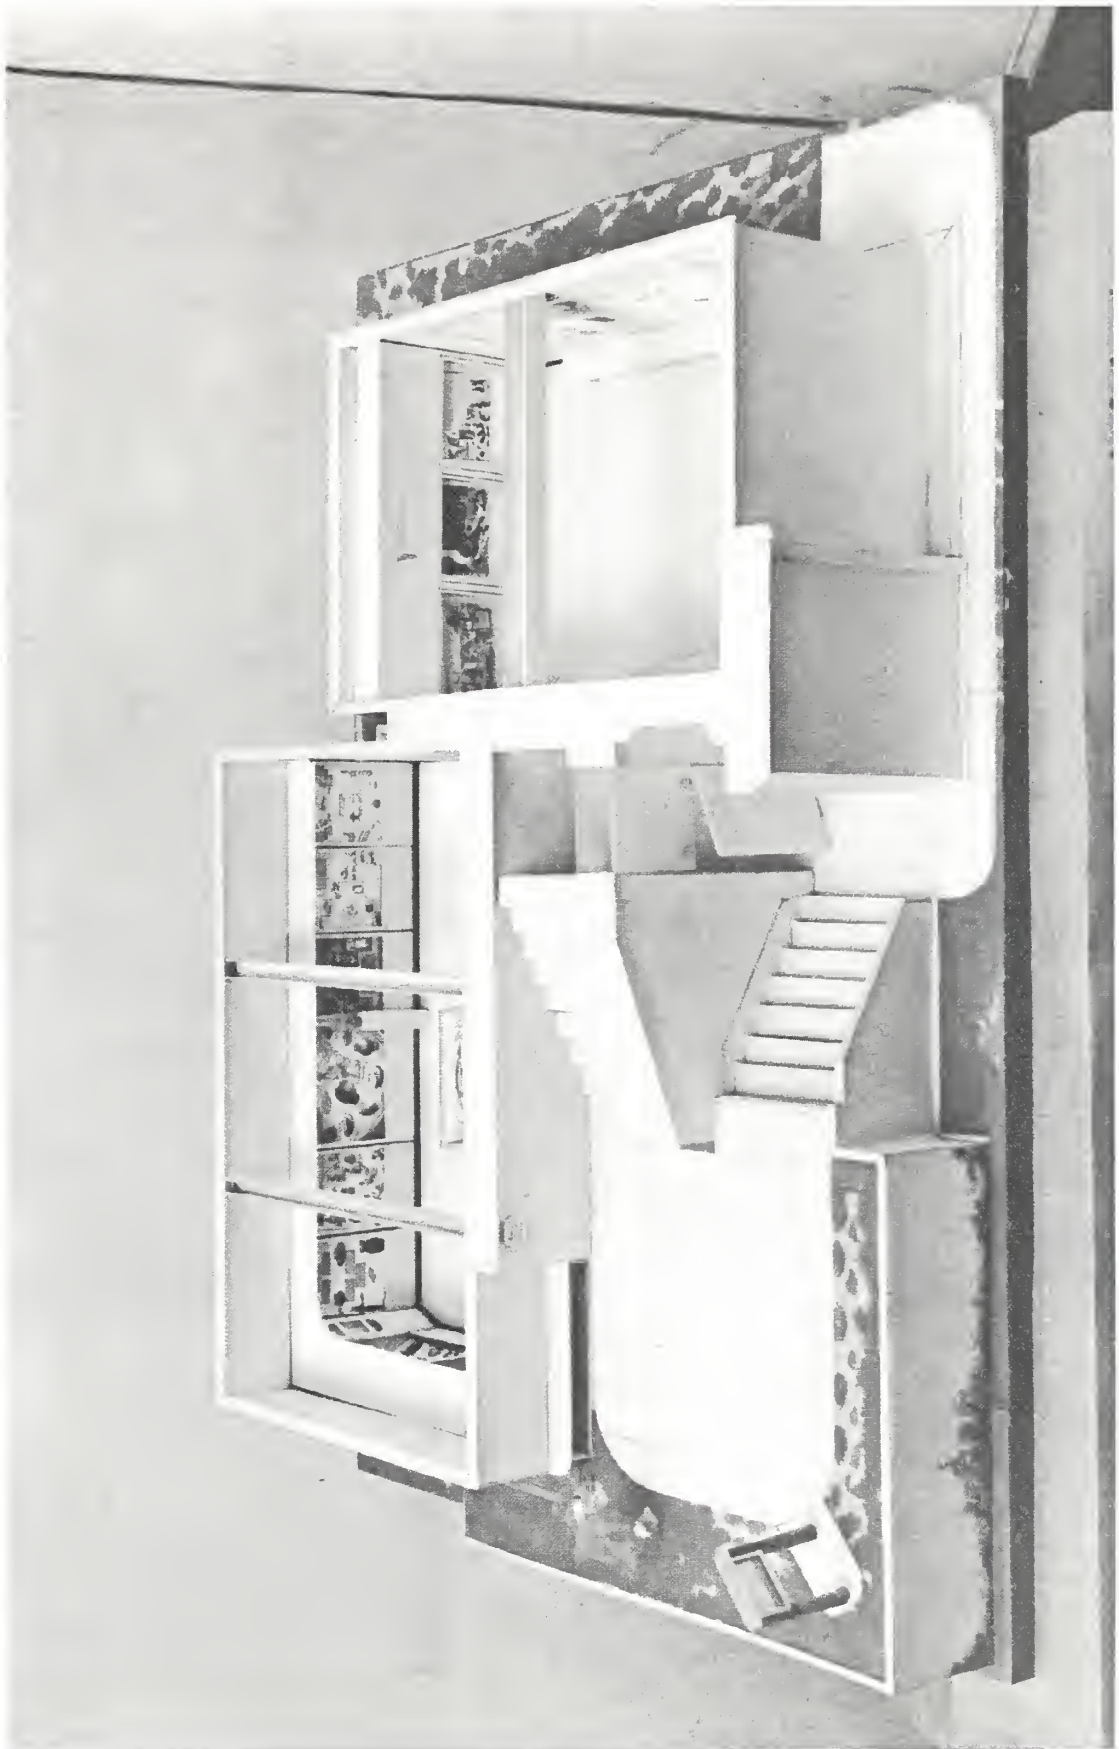
37. "Museum Case Details for Room 19." November, 1938, Plan by Lyle Bennett, Museum Collection, Archives, Petrified Forest National Park, Petrified Forest, Arizona, PF 3100-D, Sheet 13A.

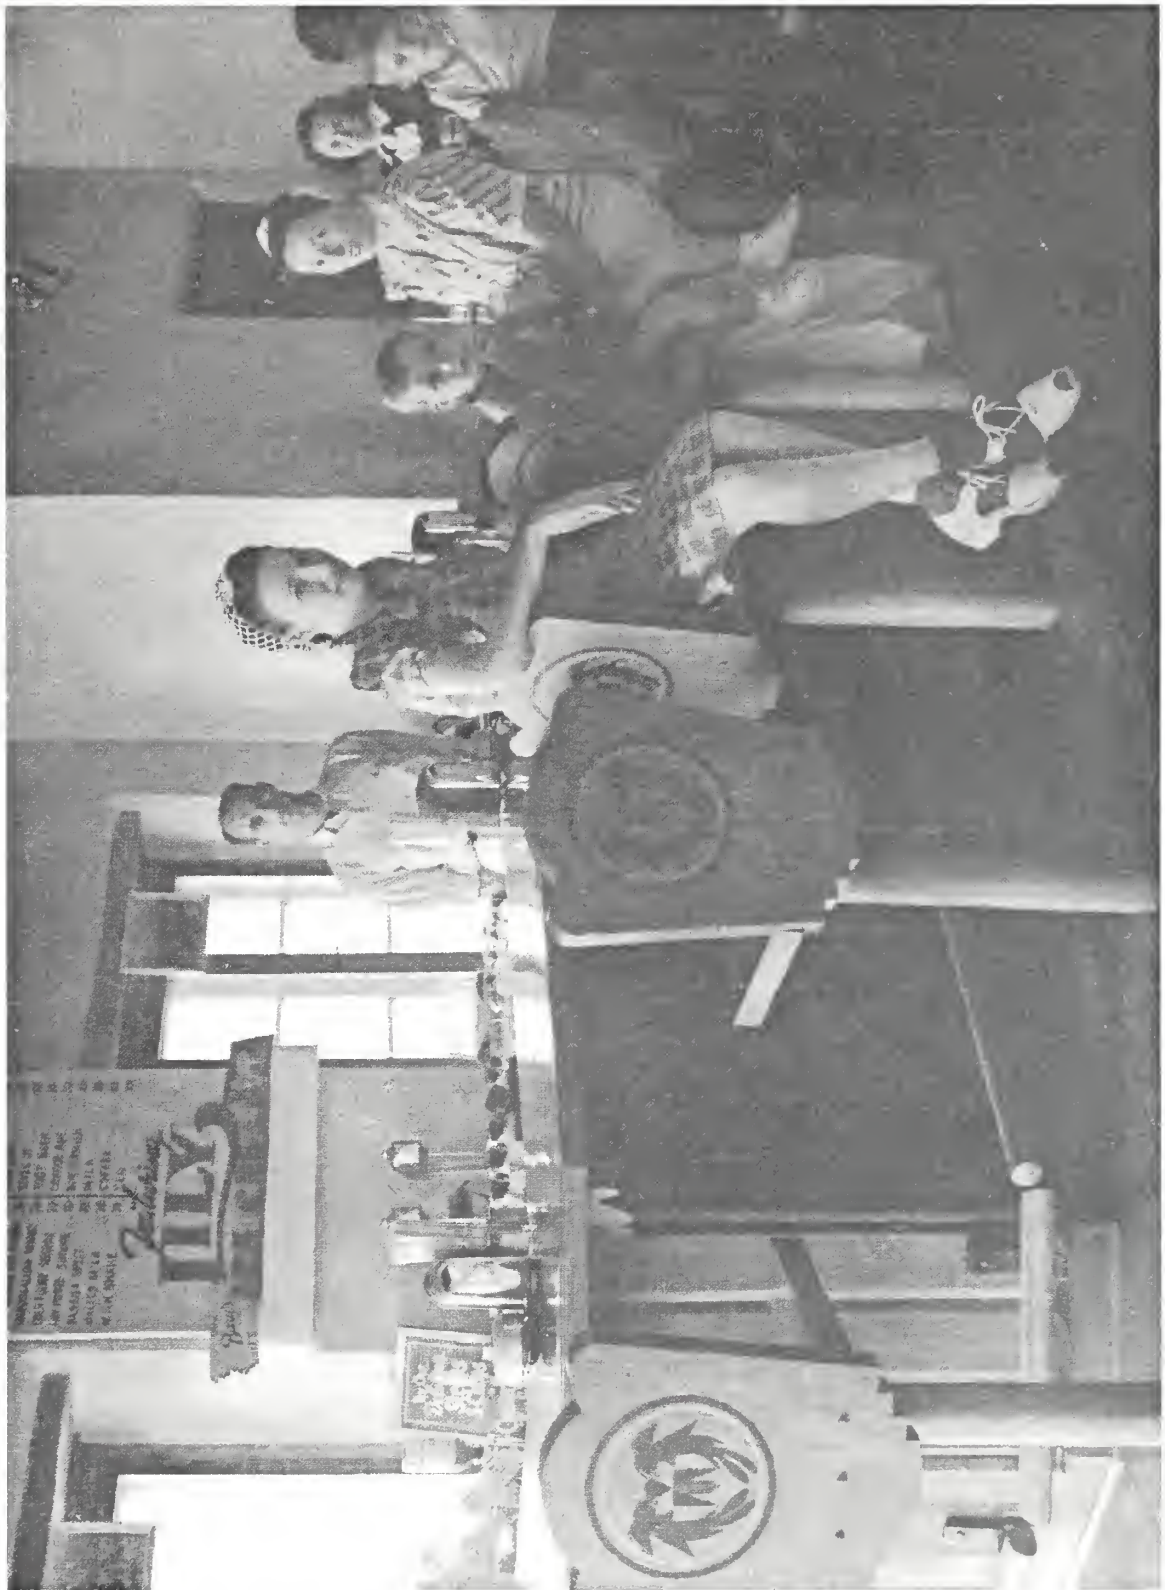
54. "Lunchroom Layout." March 3, 1939, Plan by Lyle Bennett, Museum Collection, Archives, Petrified Forest National Park, Petrified Forest, Arizona, PF 3100-E, Sheet 1.

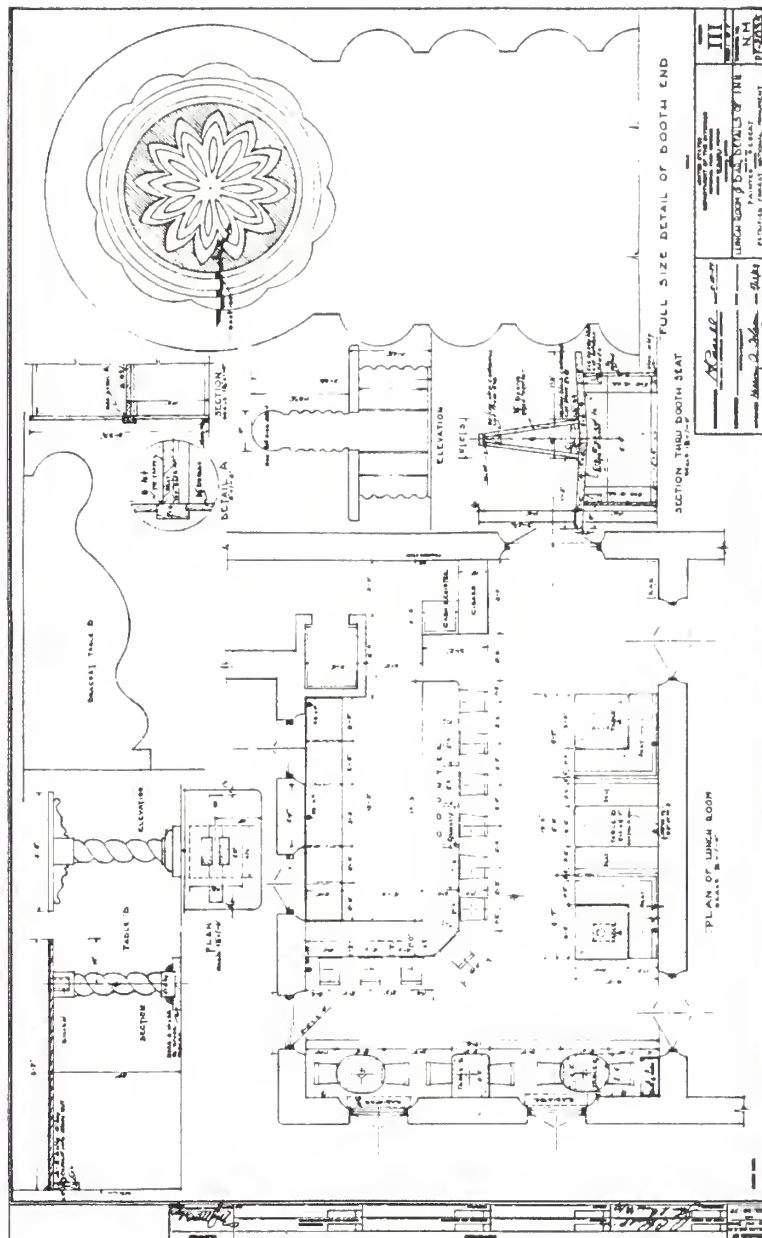
56. "Lunchroom and Bar Details." March 30, 1939, Plan by Lyle Bennett, Museum Collection. Archives, Petrified Forest National Park, Petrified Forest, Arizona, PF 2035, Sheet 1.

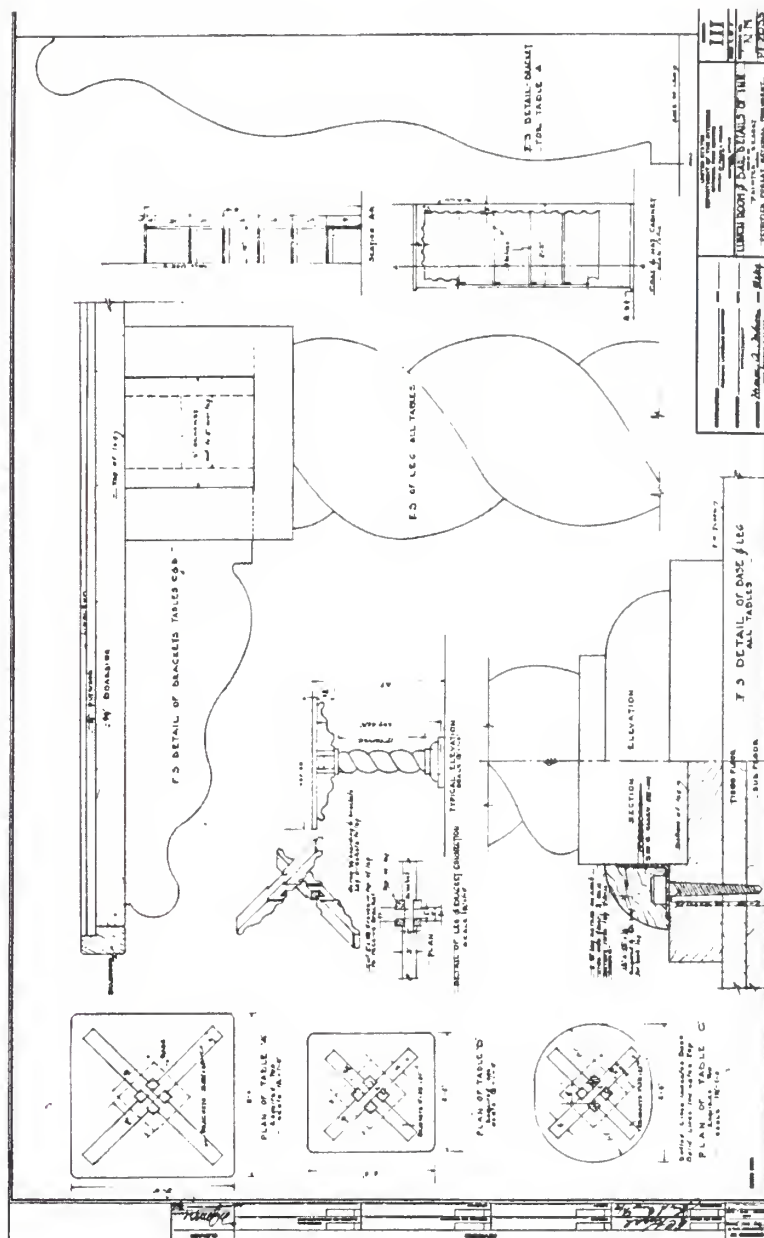
57. "Lunchroom and Bar Details." March 30, 1939, Plan by Lyle Bennett, Museum Collection, Archives, Petrified Forest National Park, Petrified Forest, Arizona, PF 2035, Sheet 2.

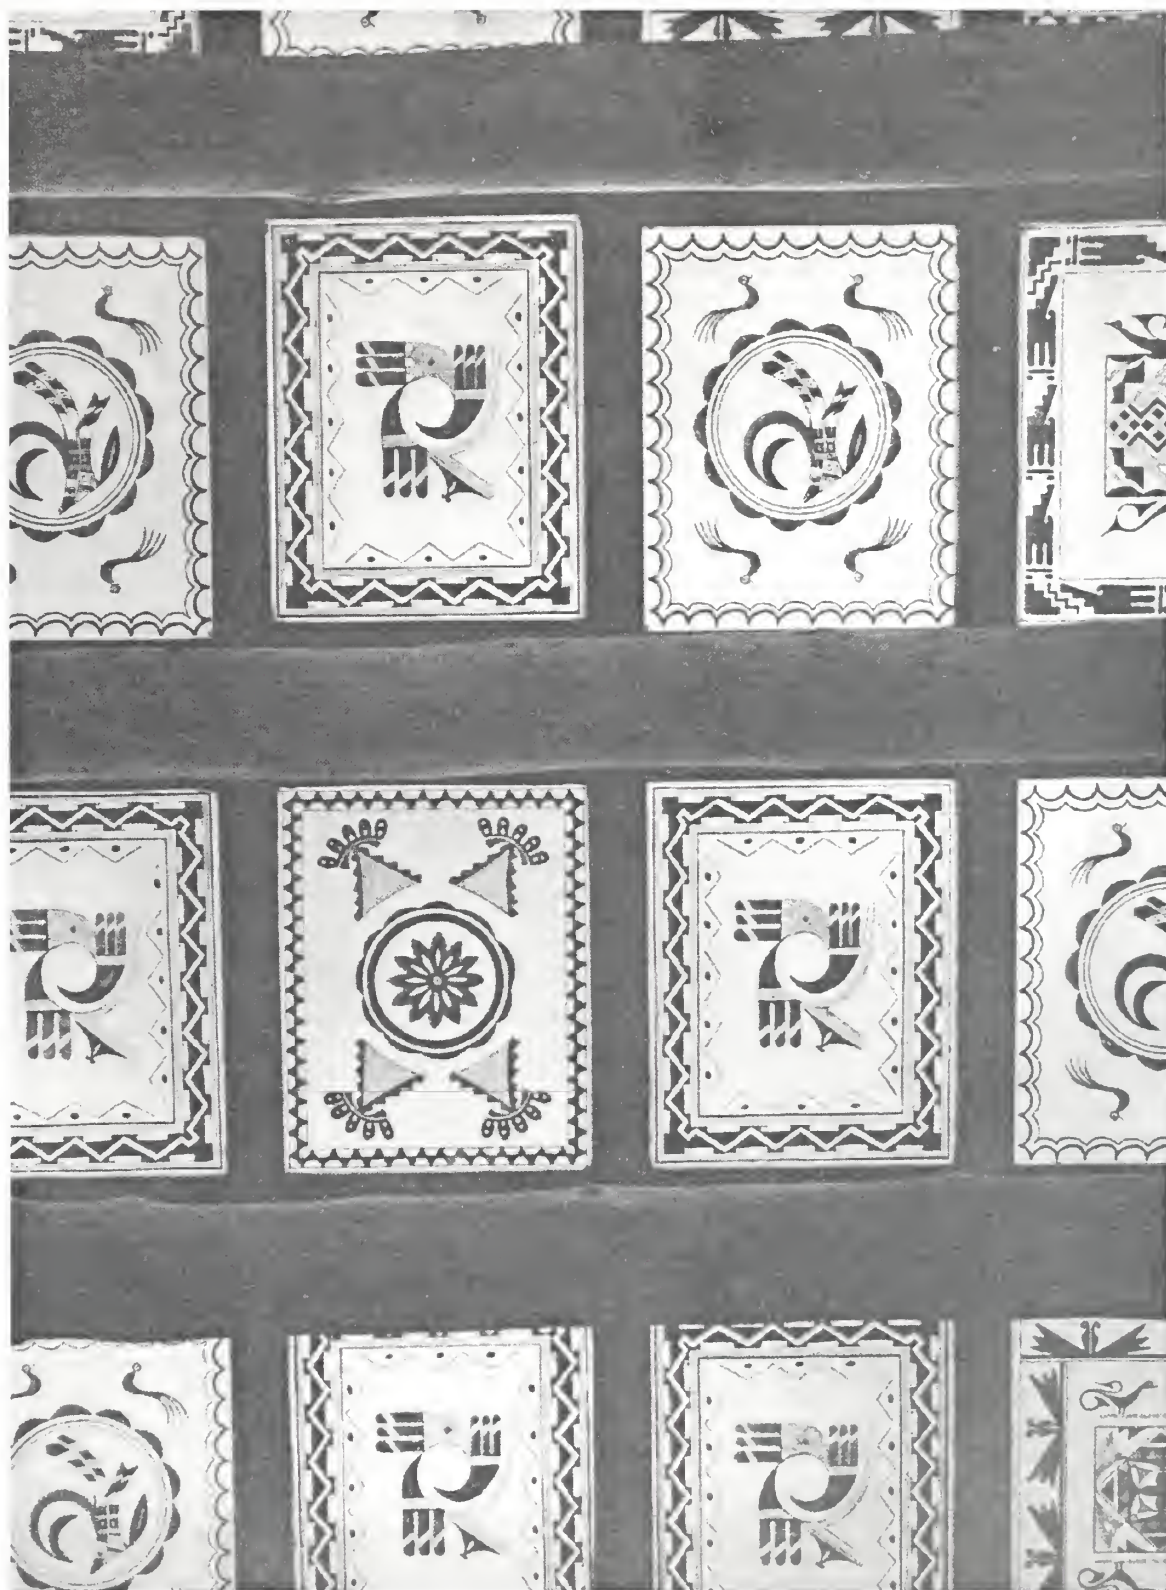
65. "Skylight Details. Multiple Glass Panels, Trading Post Room, (Room 104)." 1975, Unknown Photographer. Museum Collection, Archives, Petrified Forest National Park, Petrified Forest, Arizona, PEFO CAT. # 20756.

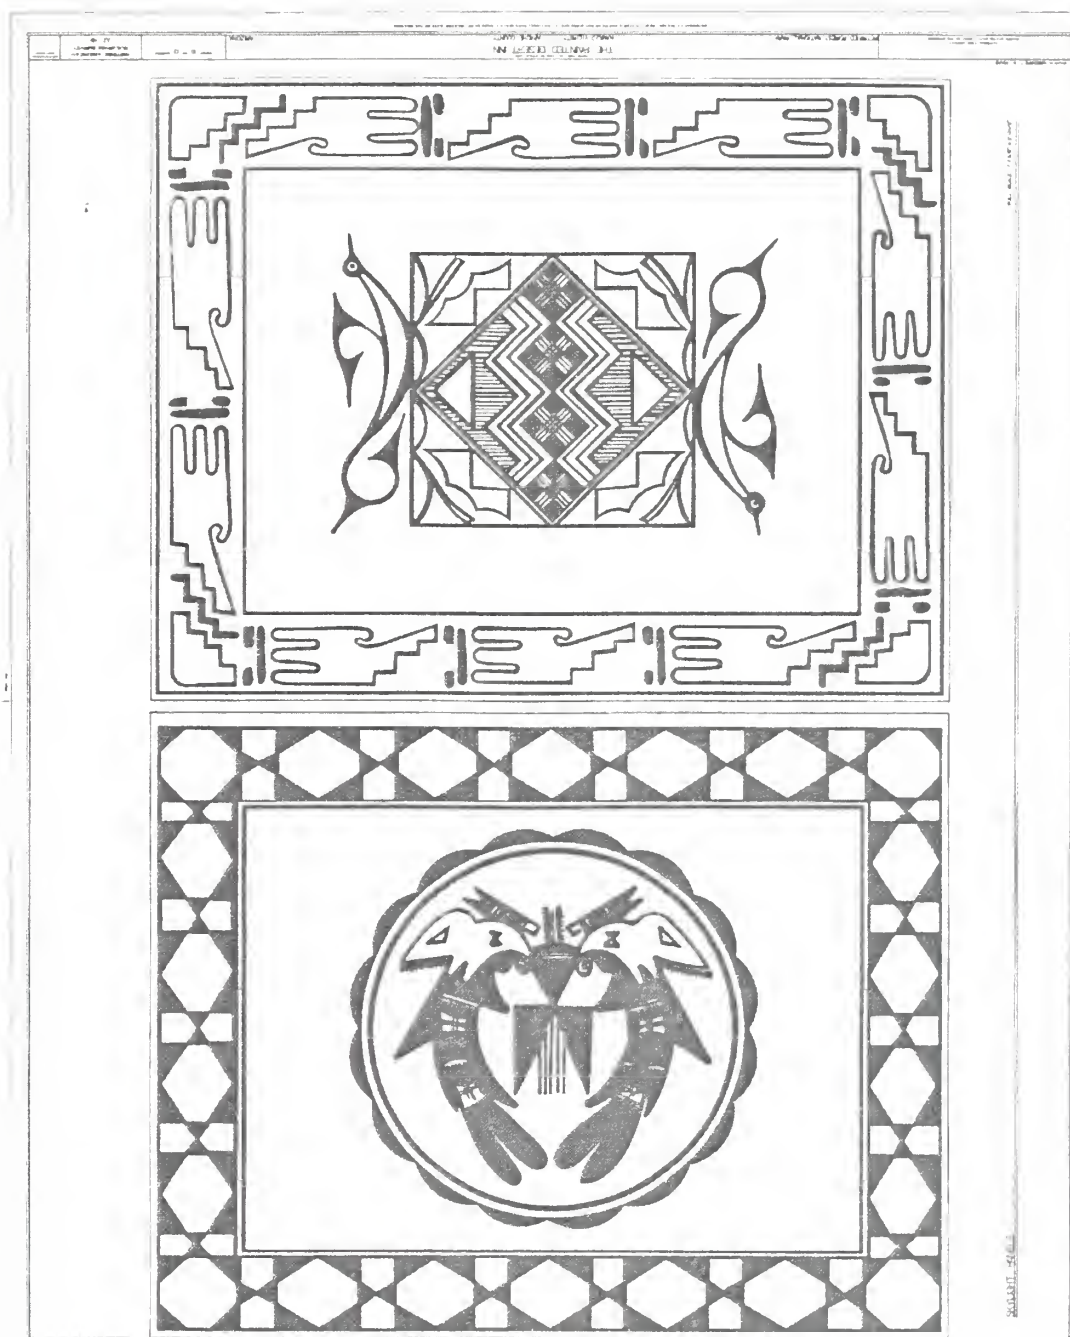
66. "Skylight Details, Trading Post Room, (Room 104)." 1992, Drawing by Historic American Buildings Survey, Museum Collection, Archives, Petrified Forest National Park, Petrified Forest, Arizona, HABS: AZ-161, sheet 10 of 12.
